Successful retrieval of a hydrophilic guidewire coating

Robert Juszkat¹, Bartosz Żabicki¹, Marek Grygier², Bogdan Pawlak¹

¹ Department of Radiology, Poznan University of Medical Sciences, Poznan, Poland

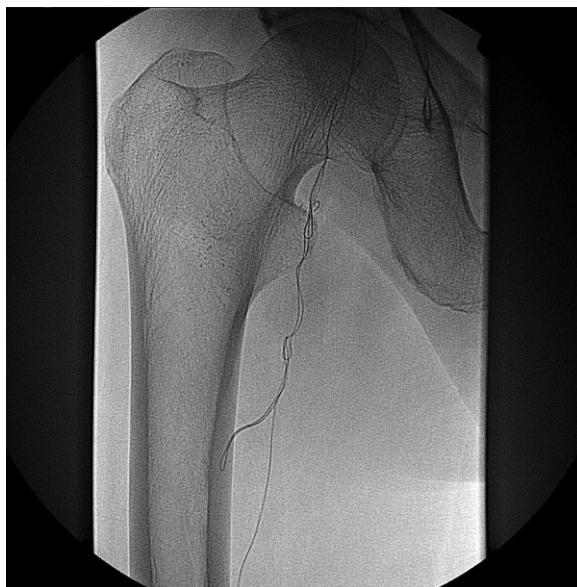
Figure 1 a. A foreign body located at the course of the right external iliac, common femoral and deep femoral arteries.

guidewire, and especially its withdrawal contributed to the detachment of its coating by stripping it off against the bevel of the needle. The detached coating was lost in the vascular lumen. The procedure was canceled at this point and the case was discussed by cardiologists, vascular surgeons and a radiologist. An interventional radiologist suggested an attempt to retrieve the guidewire coating using an endovascular technique. On the same day, the presence of the coating was confirmed at the course of right external iliac, common femoral and deep femoral arteries by fluoroscopy (Fig. 1a). The right common iliac artery was catheterized from the contralateral side in so-called cross-over way. Catheterization was assisted with a Tonnelier 5F catheter (Balton, Poland). The catheter was placed near the proximal end of the lost coating and a 0.009" guidewire

with a self-made loop at the end was advanced through the catheter. After the retrieval had not succeeded, two SORCERER 0.009" (Balt, France) guidewires were advanced through the catheter and the coating was finally captured with the help of these two intermingling guidewires. The coating was finally retrieved through the vascular sheath located in the left common femoral artery (Fig. 1b, 1c). The coating measured 43 cm (Fig. 1d). Control fluoroscopy confirmed complete retrieval of the coating. The procedure was performed without any complications. On the following day, coronary angiography was performed from the left femoral access. No significant changes within the coronary arteries were detected.

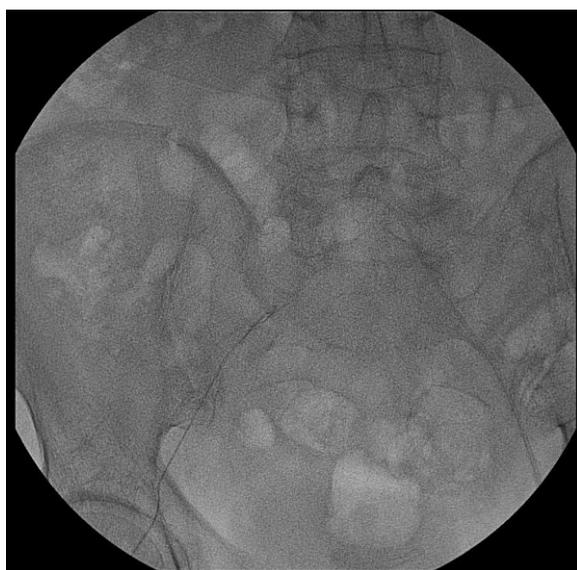
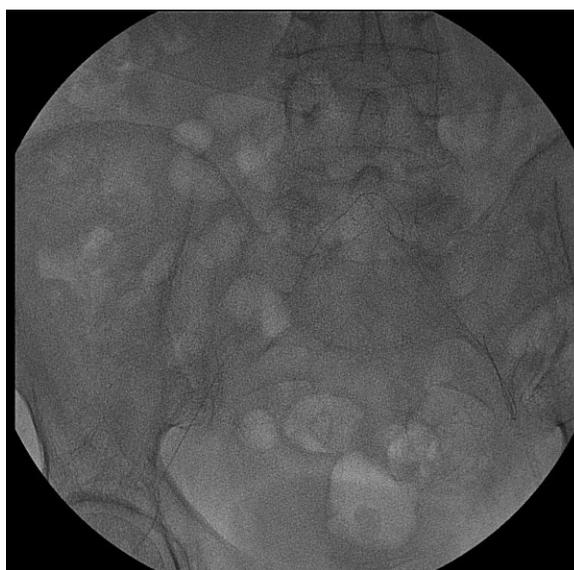
Figure 1 b, c. The coating captured. The foreign body anchored by two guidewires and a catheter withdrawn to the introducing sheath, located in the left common femoral artery.

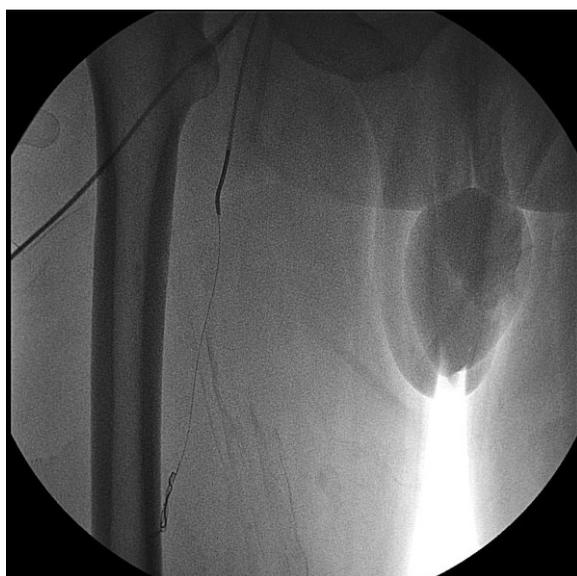
Figure 2 a. Migrated coating captured by the 0.009" guidewire in the lumen of the right deep femoral artery.

A regular 5F catheter was advanced through the introducer and it was located in the origin of the right deep femoral artery. The coating was initially captured with a help of SORCERER 0.009" guidewire (Balt, France), but during its withdrawal the coating unchained and migrated distally in the deep femoral artery. Foreign body was captured again by the same 0,009" guidewire in the deep femoral artery (Fig. 2a). The 6-7 cm long coating of the hydrophilic

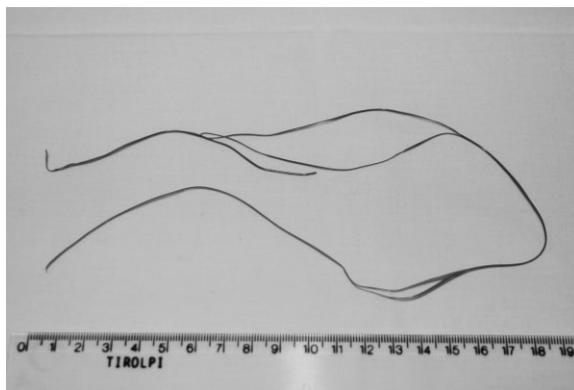
Figure 1 d. 43 cm long coating of the hydrophilic guidewire after its retrieval.

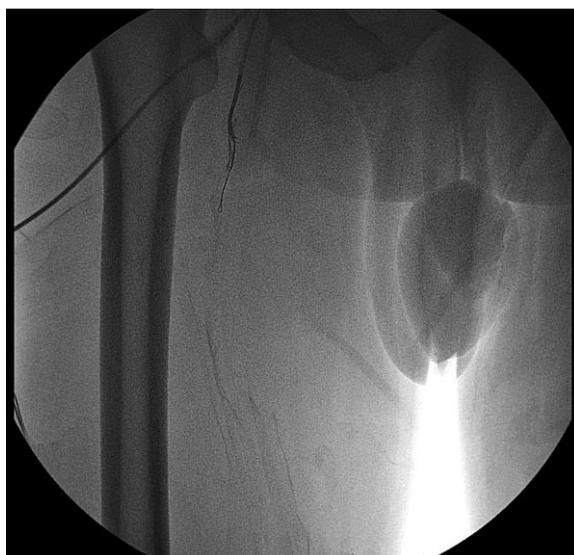
Figure 2 b. Retrieval of the lost foreign body.

guidewire was retrieved to the introducing sheath together with the guidewire and supporting catheter (Fig. 2b). The procedure was performed without any complications.
